Annexure 4: Annual Rehabilitation Assessment Report

CALGA SAND QUARRY
Peats Ridge Road, CALGA

ANNUAL REHABILITATION ASSESSMENT REPORT

JUNE 2009

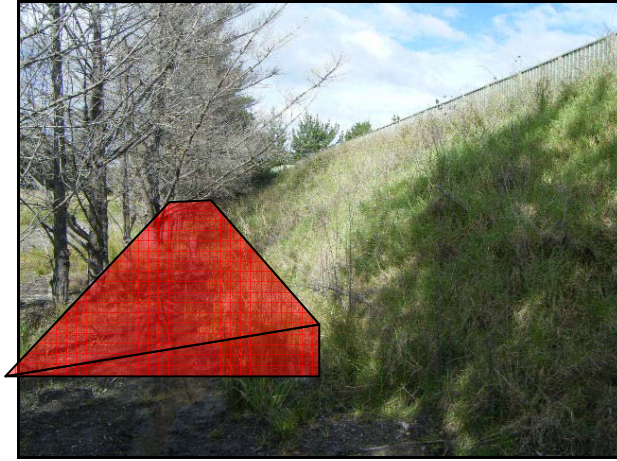
Site Entrance and Eastern Acoustic Bund

Since the formation of the bund wall in 2006, run-off from Peats Ridge Road has been diverted by the bund in a northerly direction to the formalised perimeter drain. The low gradient has caused water to pond altering the soil conditions leading to dieback of the previously established Radiata Pine trees. The affected stand of trees are losing branch segments and are exhibiting signs of being unstable, requiring their removal in the near future.

The eastern batter of the bund is heavily colonised by kikuyu, interspersed with several weed species. The bund formation is stable with no visible signs of erosion, scouring or slump. A temporary spill drain has been formed adjacent to the site entrance, allowing road run-on into the quarry grounds. The drain is to be de-commissioned and backfilled to maintain flows in a northerly direction to the existing perimeter drain.

The recommendations for this area are:

- The affected pine trees are to be removed, and following this, a graded amount of fill could be placed from the lower bund wall to the front boundary to prevent road run-off ponding at the base of the bund and saturating soils.(Depicted above)
- The placed soil should be stabilised with surface protection such as forest/tub ground mulch or similiar and selectively planted with moisture tolerant indigenous shrub and tree species. (Species to be determined)

- In the longer term, the bund wall should be selectively planted with vigorous indigenous shrubs to 'shade out' the kikuyu.

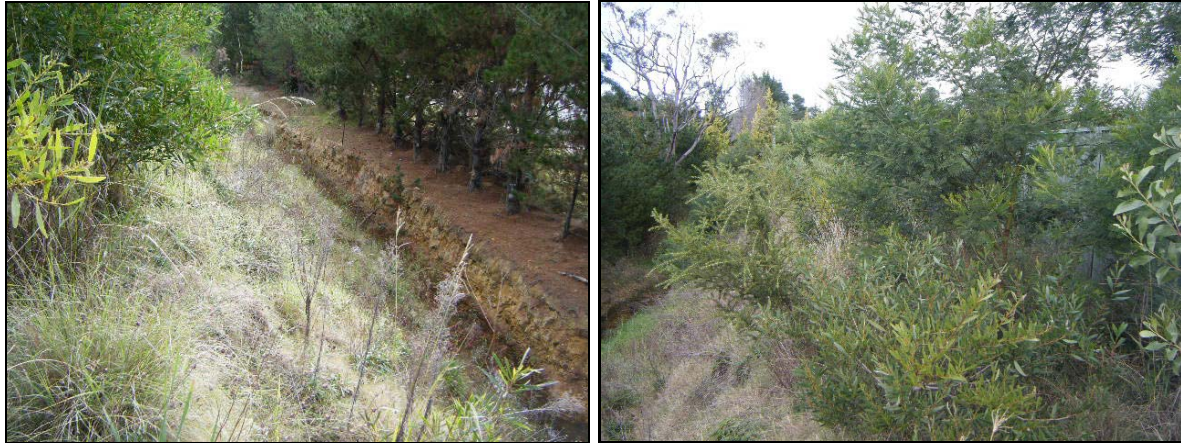
North Eastern Acoustic Bund and Perimeter Drain

The bund wall was noted to have areas of slump or scouring in isolated areas from previous severe weather events prior to the establishment of significant canopy species. The perimeter drain was also noted to have several areas of minor wall slumping.

The bund batter is primarily colonised by various grasses interspersed with weed outbreaks.

The top of the bund formation is relatively level and of varying width. The level areas resisted seed/seedling loss during past severe weather events and many areas are heavily colonised with acacia species providing a canopy cover interspersed with healthy indigenous species such as banksia and lomandra. The areas of vigorous growth have 'shaded out' invasive weed and grasses, and indigenous grasses are persisting in these areas.

The recommendations for this area are:

- Remove slumped soils from within the drain to remove impediment to flows and promote maximum drainage from the north-eastern perimeter and site entrance
- Continue to monitor the drain wall at the base of the bund following heavy rainfall events to ensure in the unlikely event of further soil slump, remedial action can be undertaken in a timely manner
- Discourage any unnecessary disturbance of the revegetated areas, particularly the level top portion of the bund.

- Selective weed control is not required at present as the indigenous canopy species are dominating higher areas and should progressively colonise down slope areas.

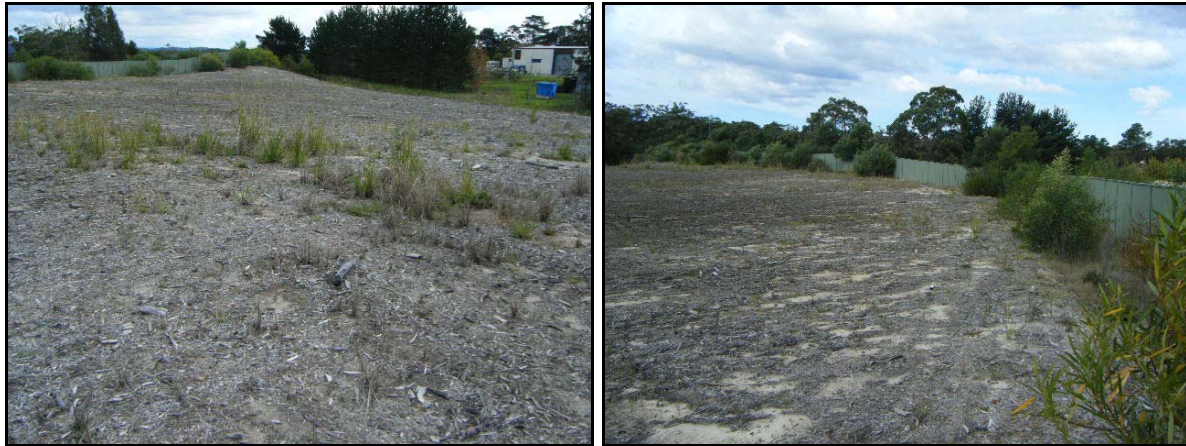
Northern Acoustic bund and fill area.

Following the formation of the bund wall in 2006, run-off from upslope areas tended to pond due to the low gradient of the area. The issue was addressed to minimise nuisance to the adjoining private property. A further quantity of topsoil fill was imported to backfill the low lying area and the perimeter drain was reformed to improve drainage and reduce soil saturation.

The backfilled area has been subsequently been lightly timber mulched and hydroseeded with a similar blend of cover crops and indigenous species. The cover crop appears to have had poor germination rates and establishment is patchy.

Established indigenous seedlings were observed at a consistent density with smaller unidentifiable native growth evident. A larger variety of germinated indigenous species was noted when compared to the eastern areas. In time, the area should be predominantly colonised by indigenous species, and particularly the Acacia species initially.

The recommendations for this area are:

- Discourage any unnecessary disturbance of the stabilised areas
- Selective weed control could be undertaken to reduce competition between native seedlings and exotic species. (The level of weed infestation is low and presents an opportunity to frustrate their establishment in this area. Note the adjoining private property is infested with weed and invasive grasses at the boundary with the area) Care should be taken to only treat identified weeds and refrain from spraying any growth not adequately identified.

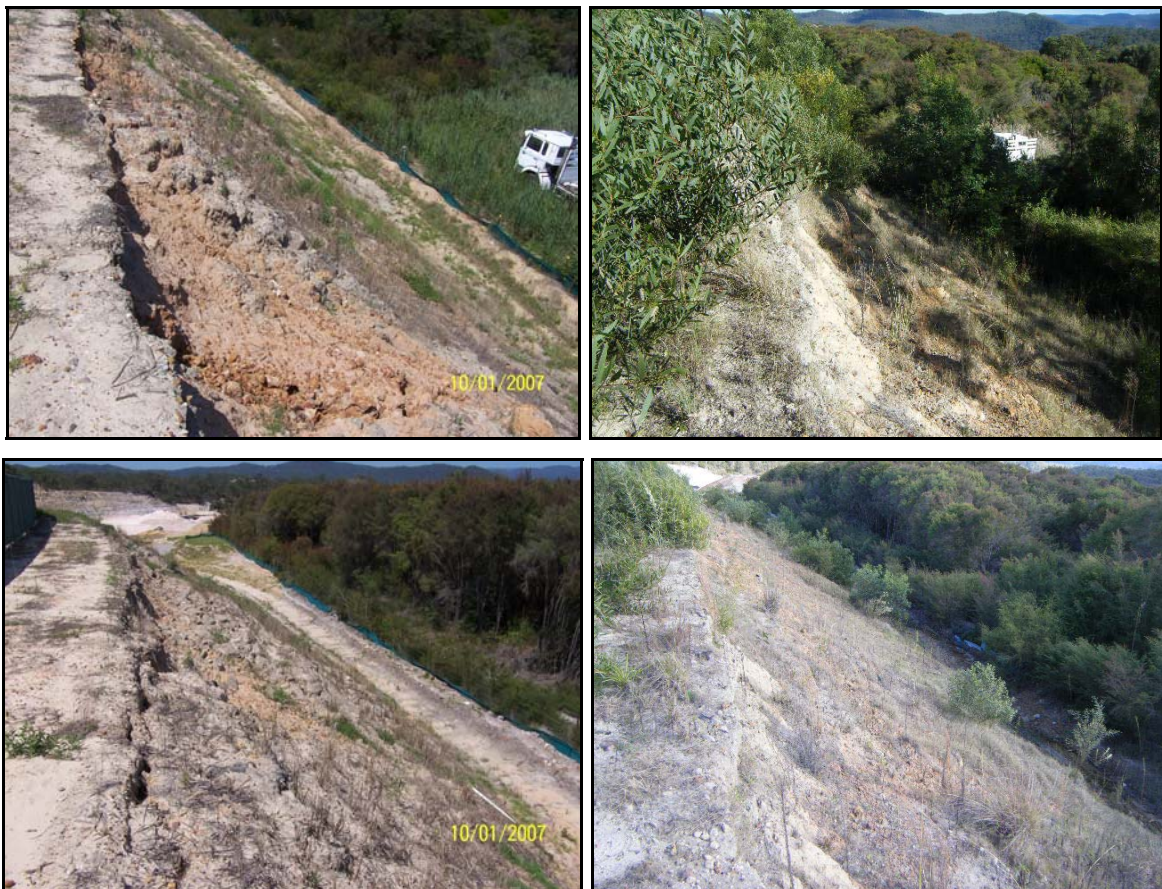
Comparative views looking South - West

The western bund wall was noted to have areas of slump or scouring in isolated areas from previous severe weather events prior to the establishment of significant canopy species. The perimeter drain was also noted to have scoured at the base to the underlying sandstone with several areas of minor wall slumping observed.

The area has a westerly aspect and is generally subjected to harsher climatic conditions such as dry winds and afternoon sun. The conditions are less favourable for seedling establishment and overall growth rates than for the eastern areas.

The bund batter is primarily colonised by various exotic grasses interspersed with weed outbreaks. The adjoining private property has uncontrolled areas of weed and pasture grasses (Crofton Weed, Pampas Grass, Stinky Roger, Whisky Grass, Kikuyu, etc) providing an ongoing opportunity for vectors to infest this area, making weed suppression difficult. The batter areas are at a significant disadvantage compared to other areas with regard to micro-climate and weed control.

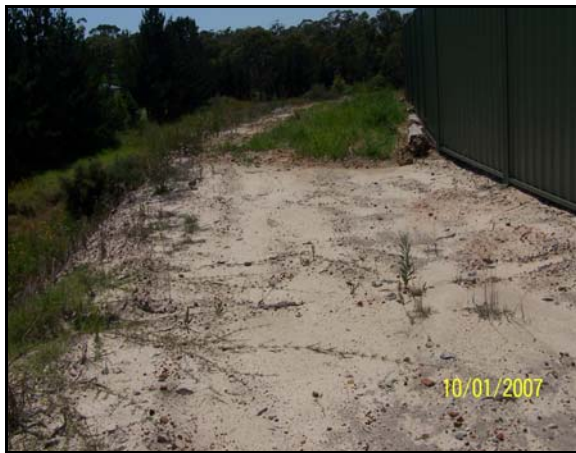
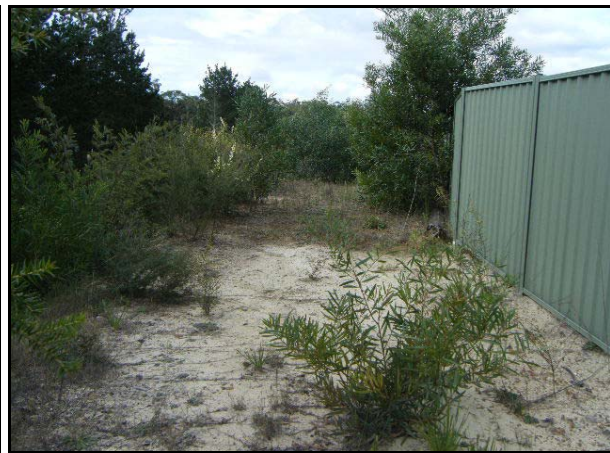
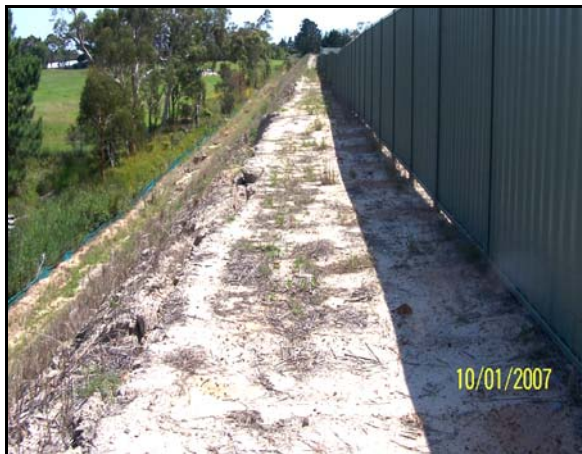
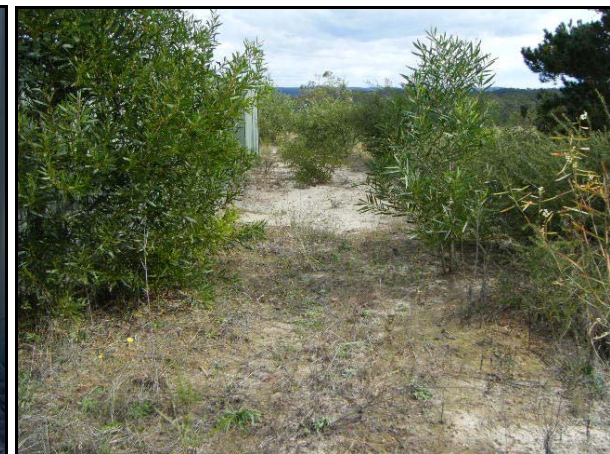
Comparative view looking North - East

The top of the bund formation is relatively level, of varying width, with a gentle grade in a south-westerly direction. The area is colonising in places with indigenous species providing an intermittent canopy cover interspersed with occasional indigenous species such as banksia and lomandra. The areas of vigorous growth are beginning to 'shade out' invasive weed and grasses, and indigenous grasses are establishing.

The recommendations for this area are:

- Continue to monitor the drain wall at the base of the bund following heavy rainfall events to ensure in the event of any further soil slumping, remedial action can be undertaken in a timely manner
- Discourage any unnecessary disturbance of the revegetated areas, particularly the level top of the bund.

- Selective weed control could be applied in a broadscale manner on areas immediately adjoining the quarry boundary near the perimeter drain to minimise the ingress of weeds from the adjoining property.

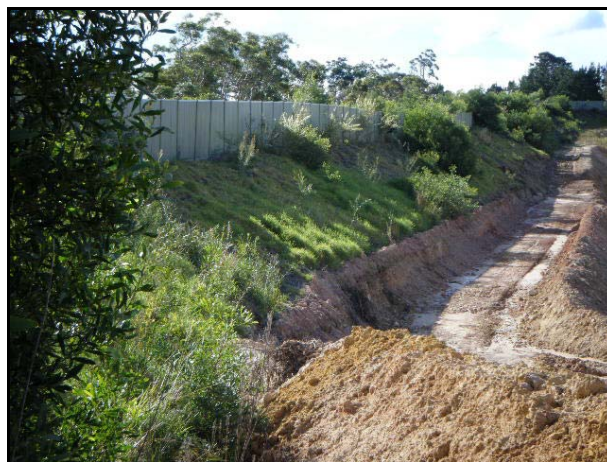
The inner bund wall was noted to have resisted erosion or scouring generally. The vegetation growth is dominated by Kikuyu, interspersed with Acacia at irregular intervals. The present diversity of indigenous species is poor. The rapid establishment of Kikuyu may have prevented germination or establishment of some species.

View of inner western bund.

Further rehabilitation in regards to vegetation diversity in the area should be addressed at the cessation of extractive activities in this sector of the quarry.

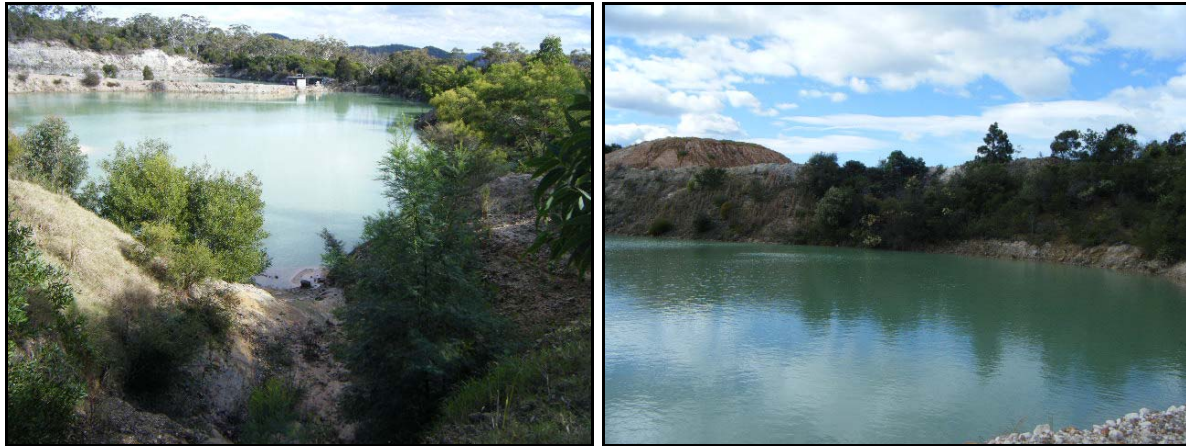
Alternate views of lower containment dam and surrounds

The surrounds of the main water containment/treatment dams remain subject to potential disturbance from quarry activities. The dam surrounds and lower perimeter are generally colonised by a variety of indigenous species with greater diversity than other quarry sectors. Weed outbreaks are scarce and well contained.

The visual appearance of water quality in the dams was good and turbidity was low, despite recent ongoing wet weather. The drainage lines from the existing quarry workings have scoured to the shallow underlying sandstone, however, further scouring will be minimal due to the erosion resistance from the stone.

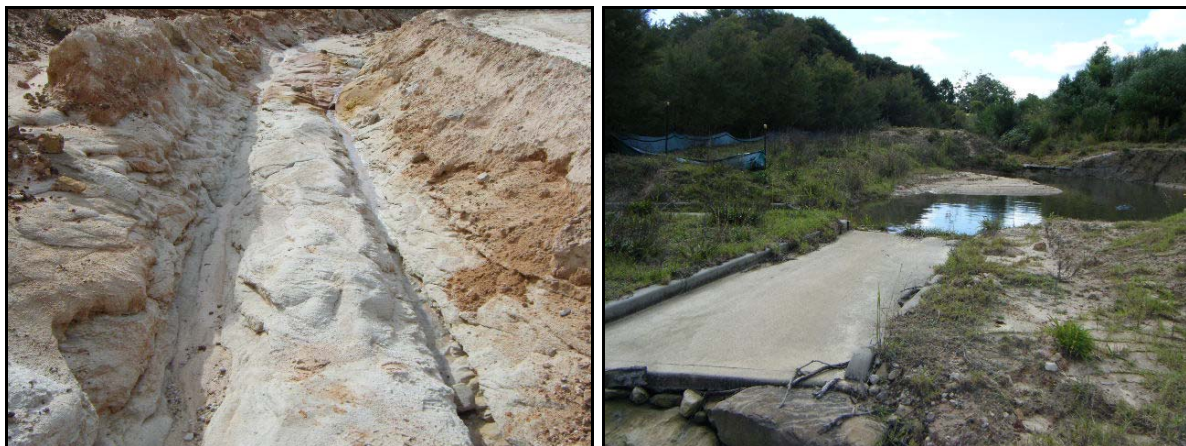
Other formalised drainage lines and detention structures in the area were inspected and found to be well maintained with small amounts of deposited sediment observed.

Views of lower drainage lines and sediment detention structure.
