CALGA SAND QUARRY

ANNUAL ENVIRONMENTAL MANAGEMENT

REPORT

2007

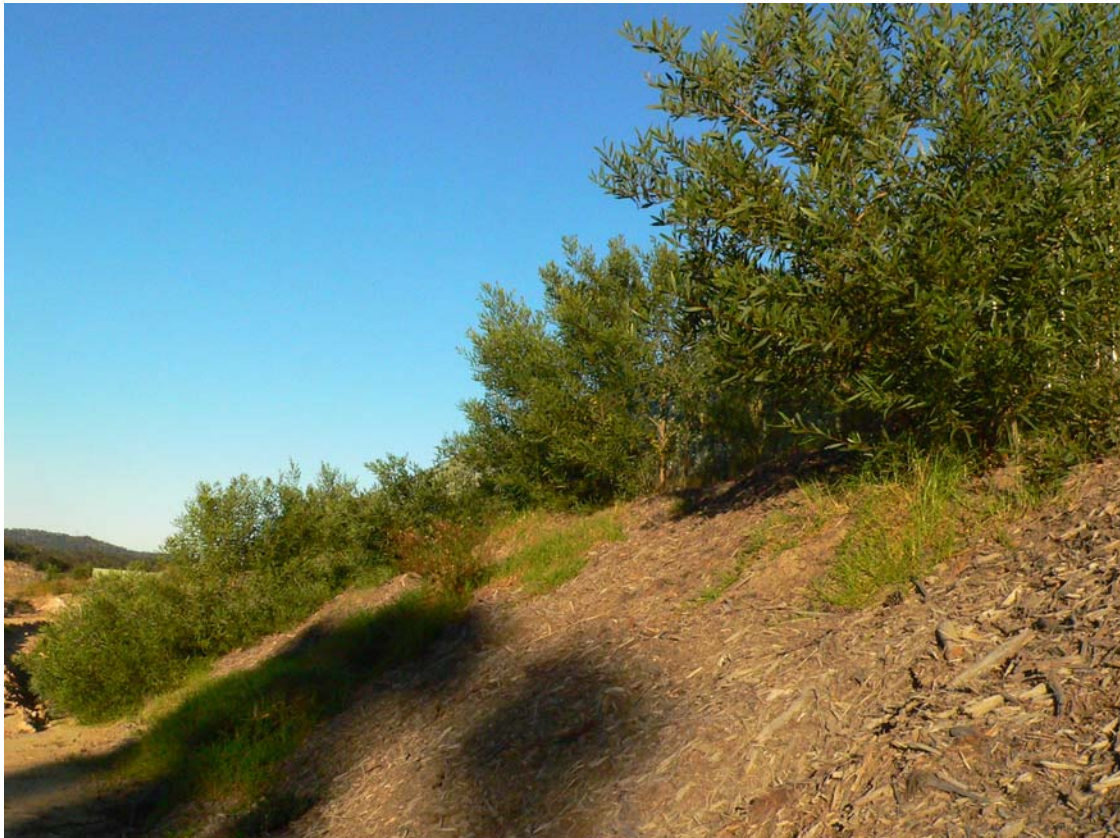
Photo mulched bund

Maintenance on the bund wall has continued with some areas covered with mulch and replanted due to high rainfall events washing soil away before the vegetation was fully established.

Rehabilitation has continued on the bund wall with mulching and continued maintenance after high rainfall caused some damage to the bund.

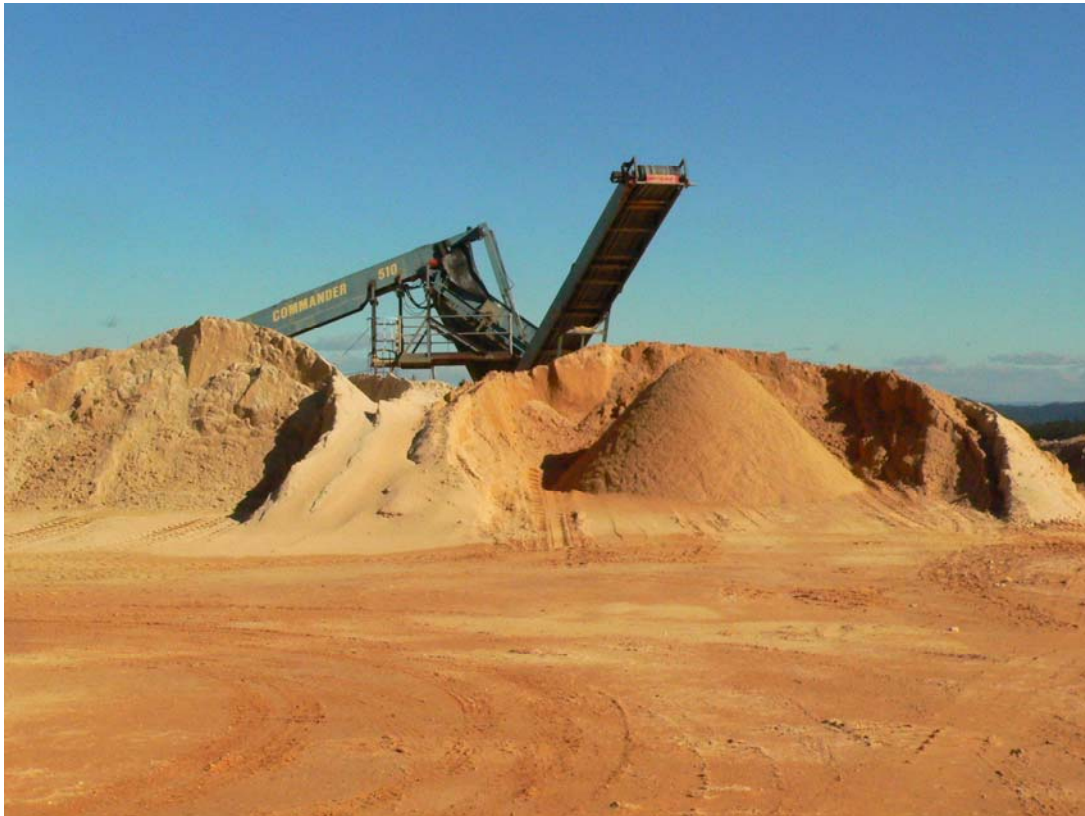
Photo – Dry Screening Plant

The Power Dry Screening continued to produce yellow and white mortar sand for bricklaying, mainly for residential markets.

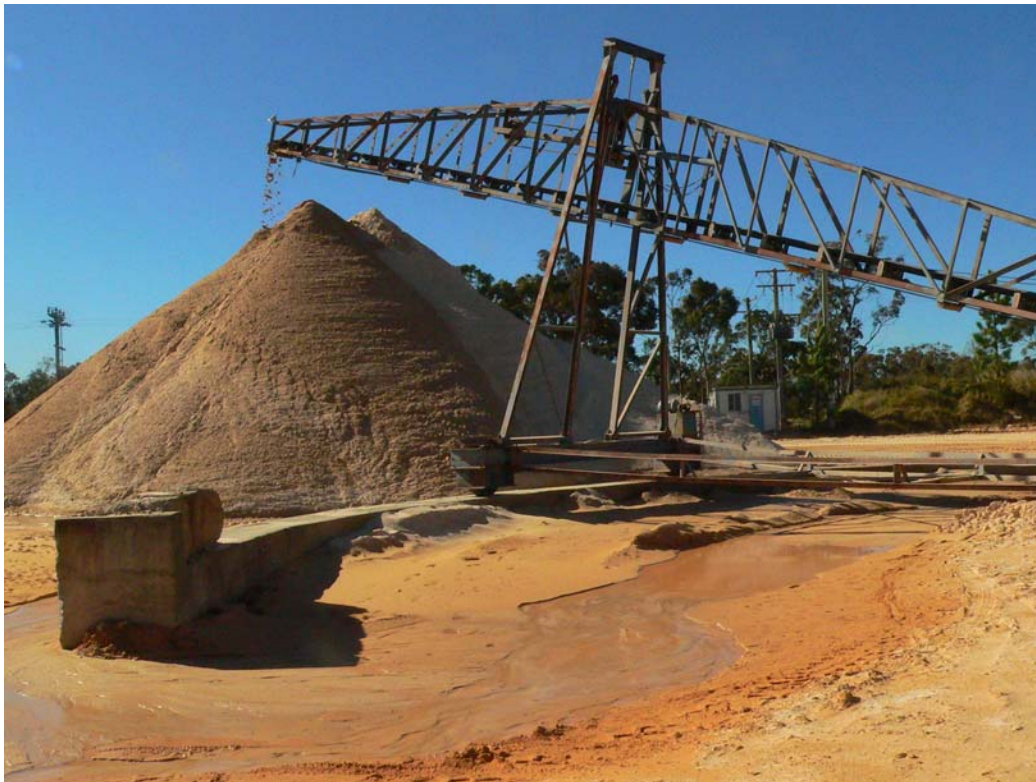
2.5 Sand processing.

Washed sand continued to be processed with production running at half rate due to depressed market and lack of sales.

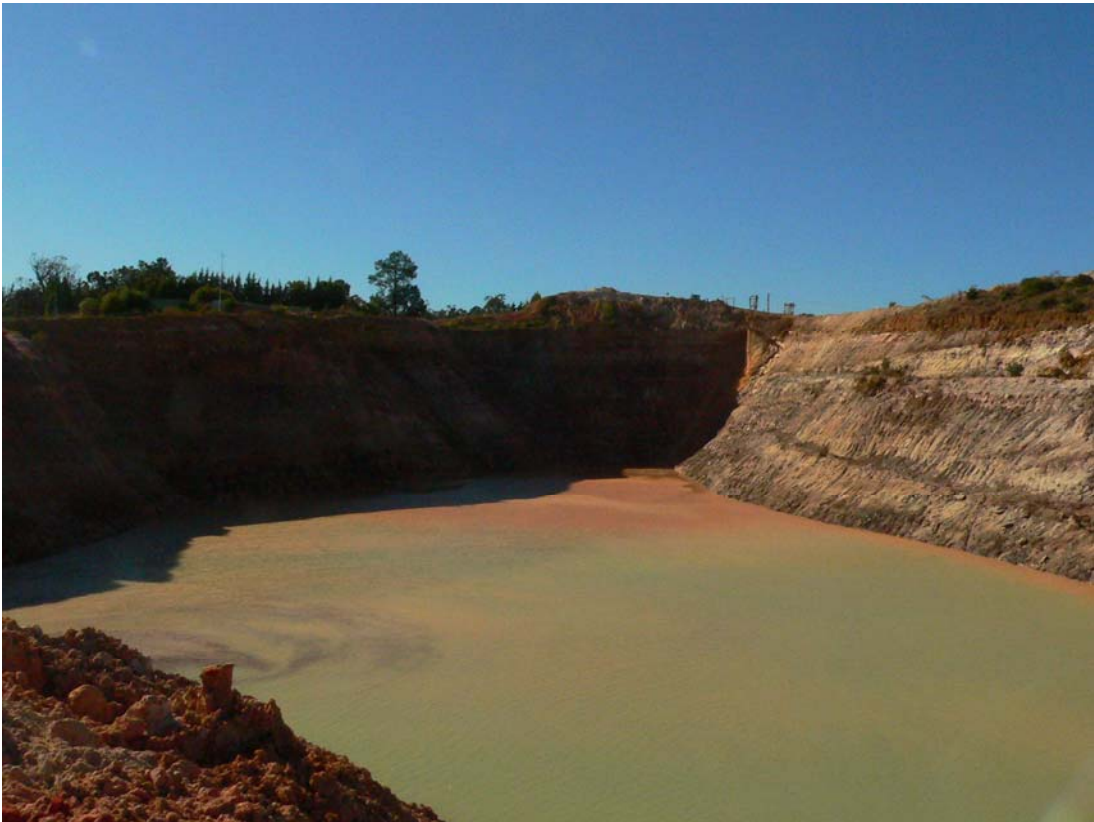
Photo cell c2bc

During the reporting period clay/silt fines were placed into cell c2bc where the clay is dewatered and the water recycled into dam 7a for processing again.

Cell c2bc will continue to be filled with silt well into the 2008 reporting period until cell 3.1 becomes available for silt storage.

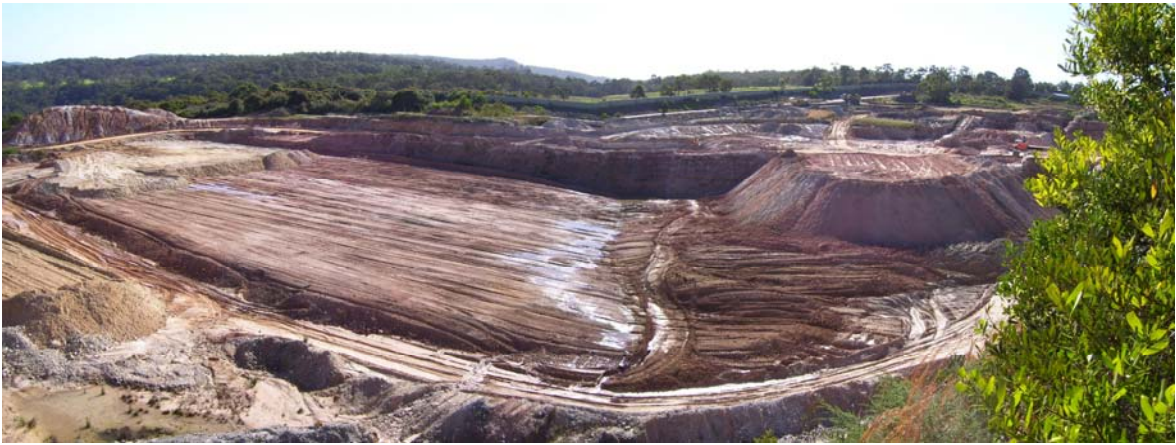
Photo Cell c3a and c3b

Capping of cell 4 was completed using clay from Cell 3.1 and sandstone rejected from the sand wash plant, Cells c3a and c3b were capped with clay overburden and reject from the wash plant in preparation for the future wash plant to be located in this area.

The majority of the Quarry stages 1 & 2 have been capped in preparation for the wash plant relocation.

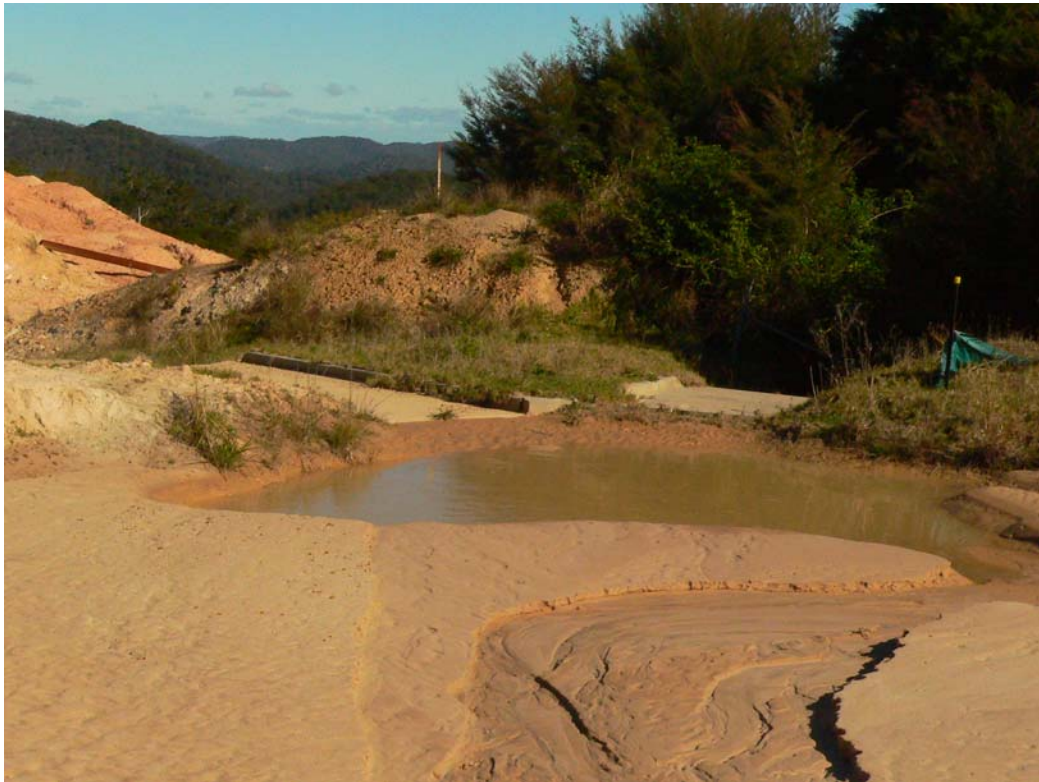
Photo sediment dam water sharing weir

The area experienced some very high rain events that caused the sediment dams to fill with sand washed down from the catchments area above them, the sediment dams collected the solids and allowed clean water to return to dam 7bc before overflowing to dam 1 and into Popran Creek. The sediment dams were cleaned out with the excavator and dump truck in preparation for future collection of sediments.

The water sharing facility was directed to Rocla for the full period as discharges were experienced from the all water storage dams in the area.

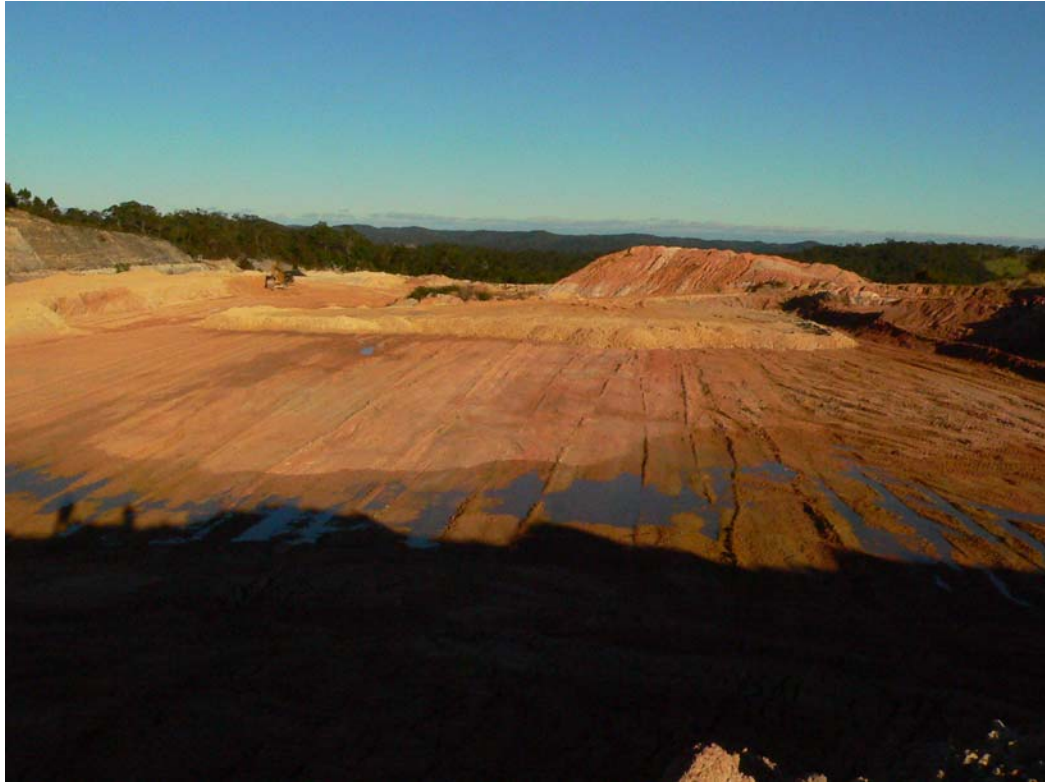
Photo capped cell 4 and 5

Silt is continuing to be capped with all of the cells capped up to c2bc. Capping of c2bc will commence later in 2008.
